RESPONSE OF WILLIAM E. WHITAKER

CERCLA 104(e) REQUEST FOR INFORMATION

SITE CHARACTERIZATION AND  
REMEDIAL ACTION CONCEPTS FOR  
THE WEST LAKE LANDFILL

Office of Nuclear Material Safety and Safeguards  
U.S. Nuclear Regulatory Commission  
Washington, DC 20555

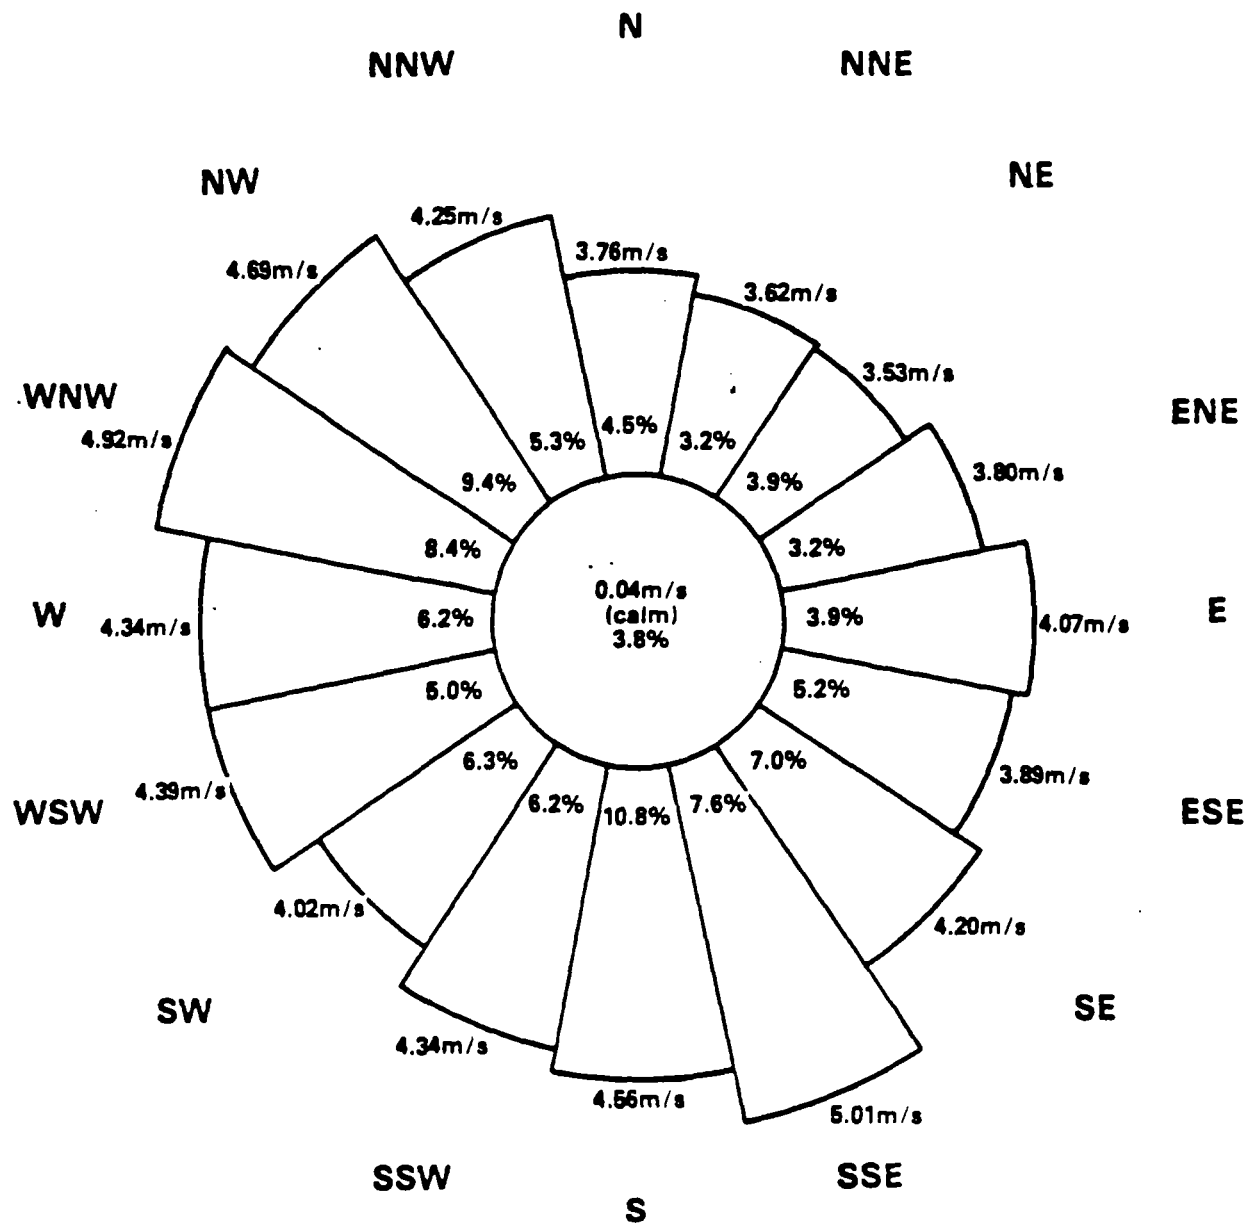
Figure 2.11. Wind distribution for West Lake area

Wind rose is for Lambert Field International Airport, Hazelwood, Missouri, and shows the percentage of hourly observations in each direction along with the average speed in that direction; for example: wind blew from the north 4.5% of the time at an average speed of 3.76 m/s.

and humidities over 80% are common during the summer. Wind during the period of December through April is generally from the northwest; winds blow mainly from the south throughout the remainder of the year. A compilation of hourly wind observations shows that although the wind resultant is fairly consistent on a monthly basis, the wind actually shifts a good deal and is very well distributed in all directions (Figure 2.11) (NRC, 1981; U.S. Department of Commerce, 1960).

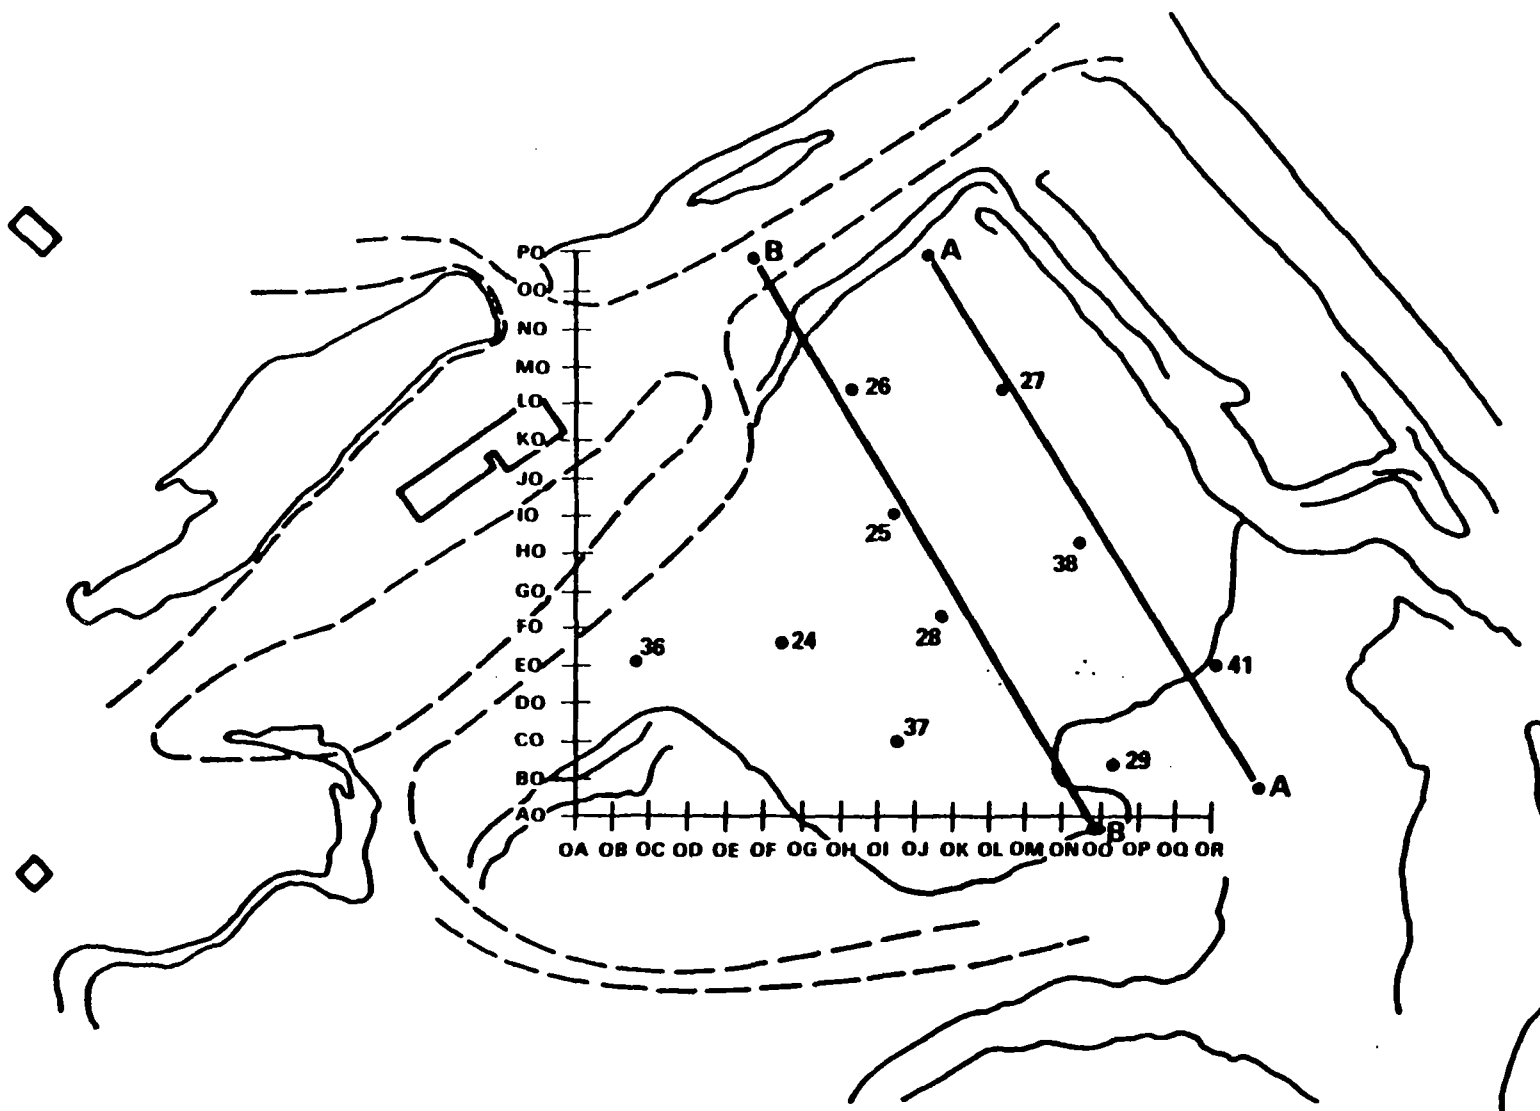
Figure 3.4 Location of auger holes, Area 1

Note: Line B-B indicates cross-sectional area shown in Figure 3.7.

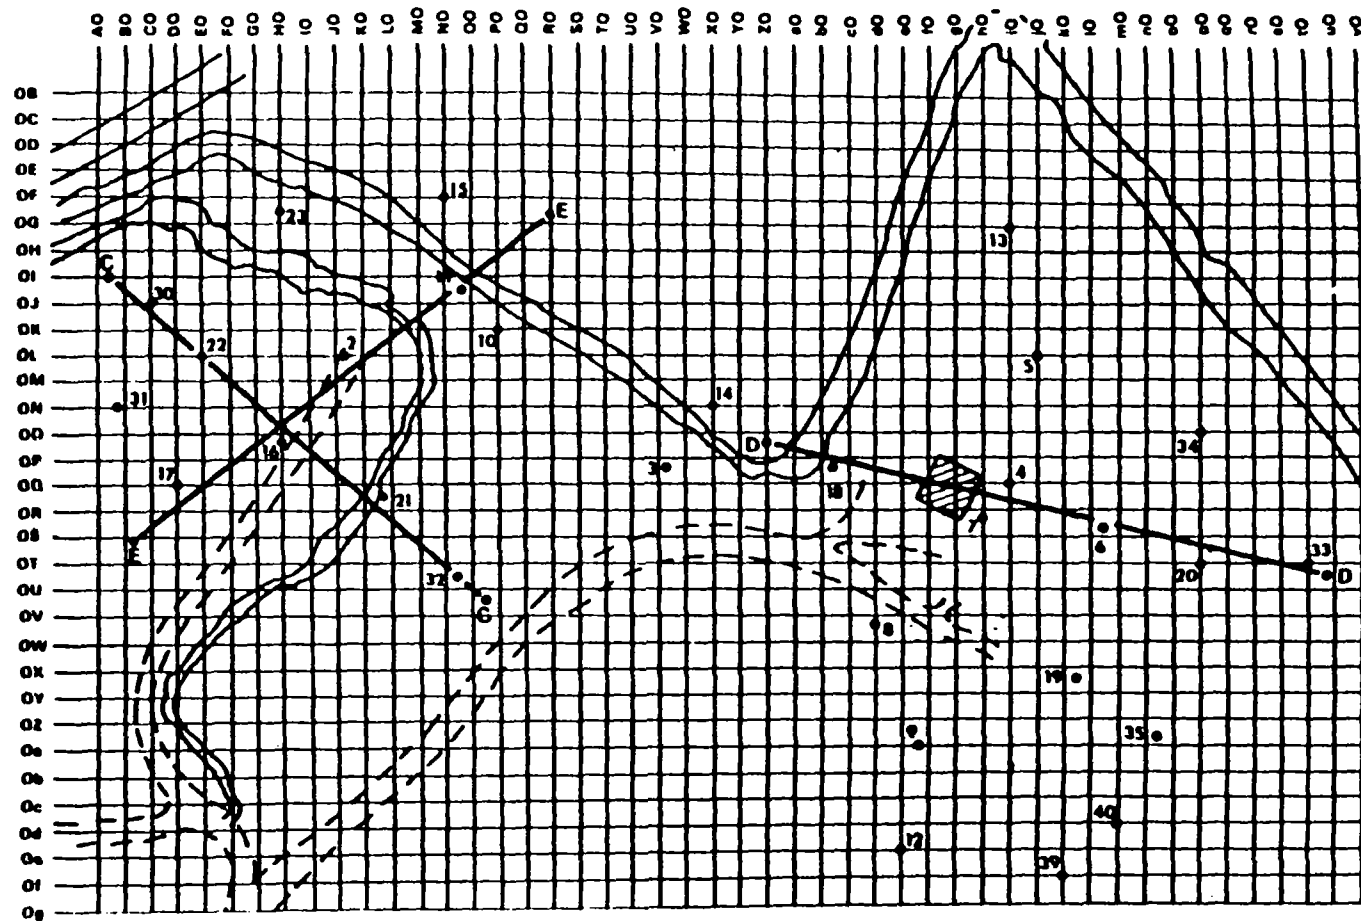
Figure 3.5 Location of auger holes, Area 2

Note: Line E-E indicates cross-sectional area shown in Figure 3.8.

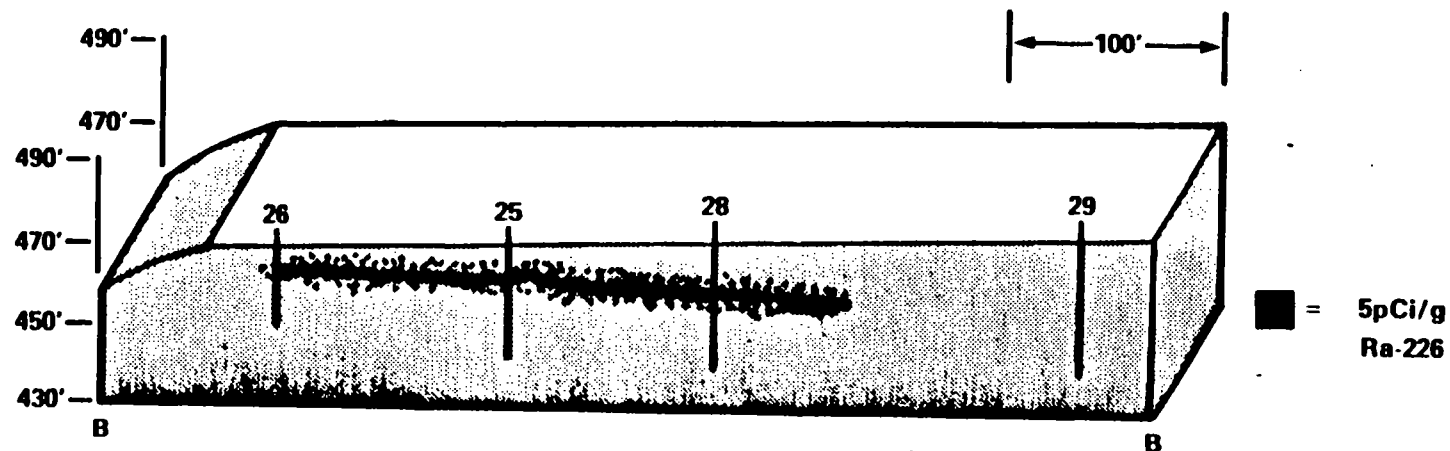
Figure 3.7 Cross-section B-B showing subsurface deposits in Area 1

- Notes: (1) B-B is defined in Figure 3.4.  
 (2) The blackened areas indicate the estimated extent of contamination exceeding 5 pCi/g Ra-226, based on surface and auger hole measurements.

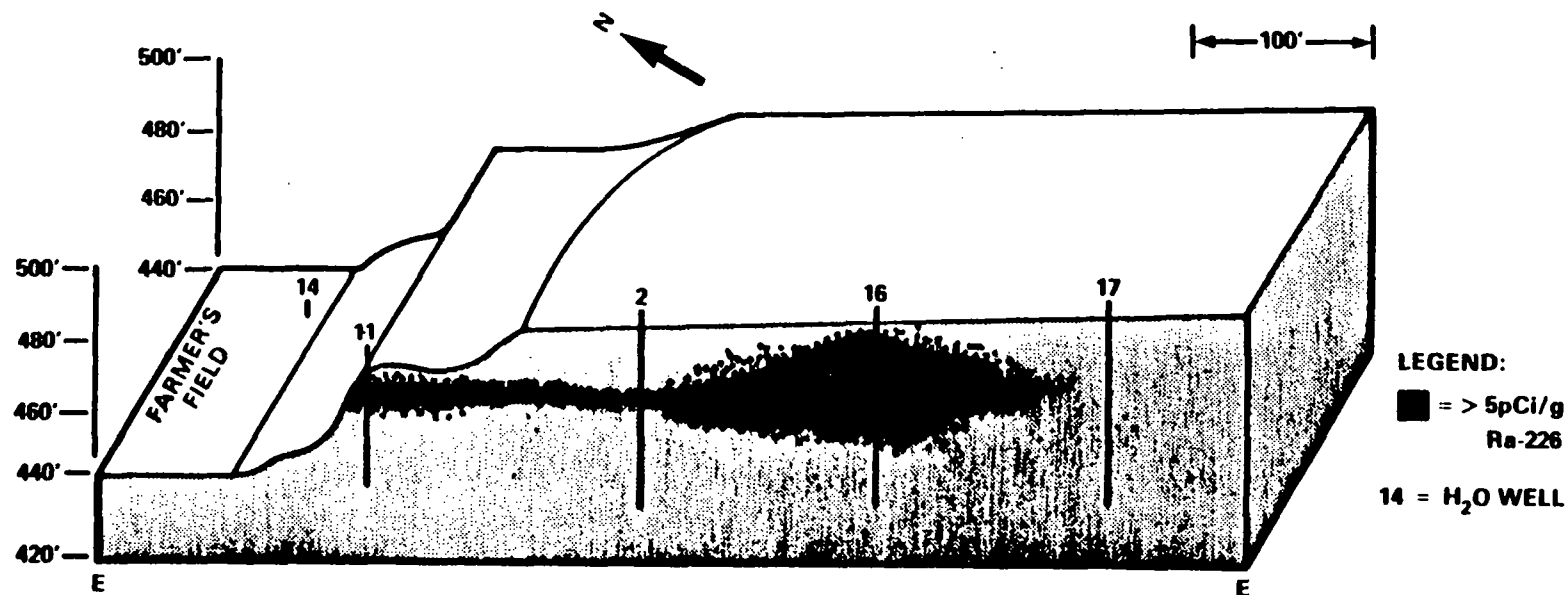
Figure 3.8 Cross-section E-E showing subsurface deposits in Area 2

- Notes: (1) E-E is defined in Figure 3.5.  
 (2) The blackened areas indicate the estimated extent of contamination exceeding 5 pCi/g Ra-226, based on surface and auger hole measurements.

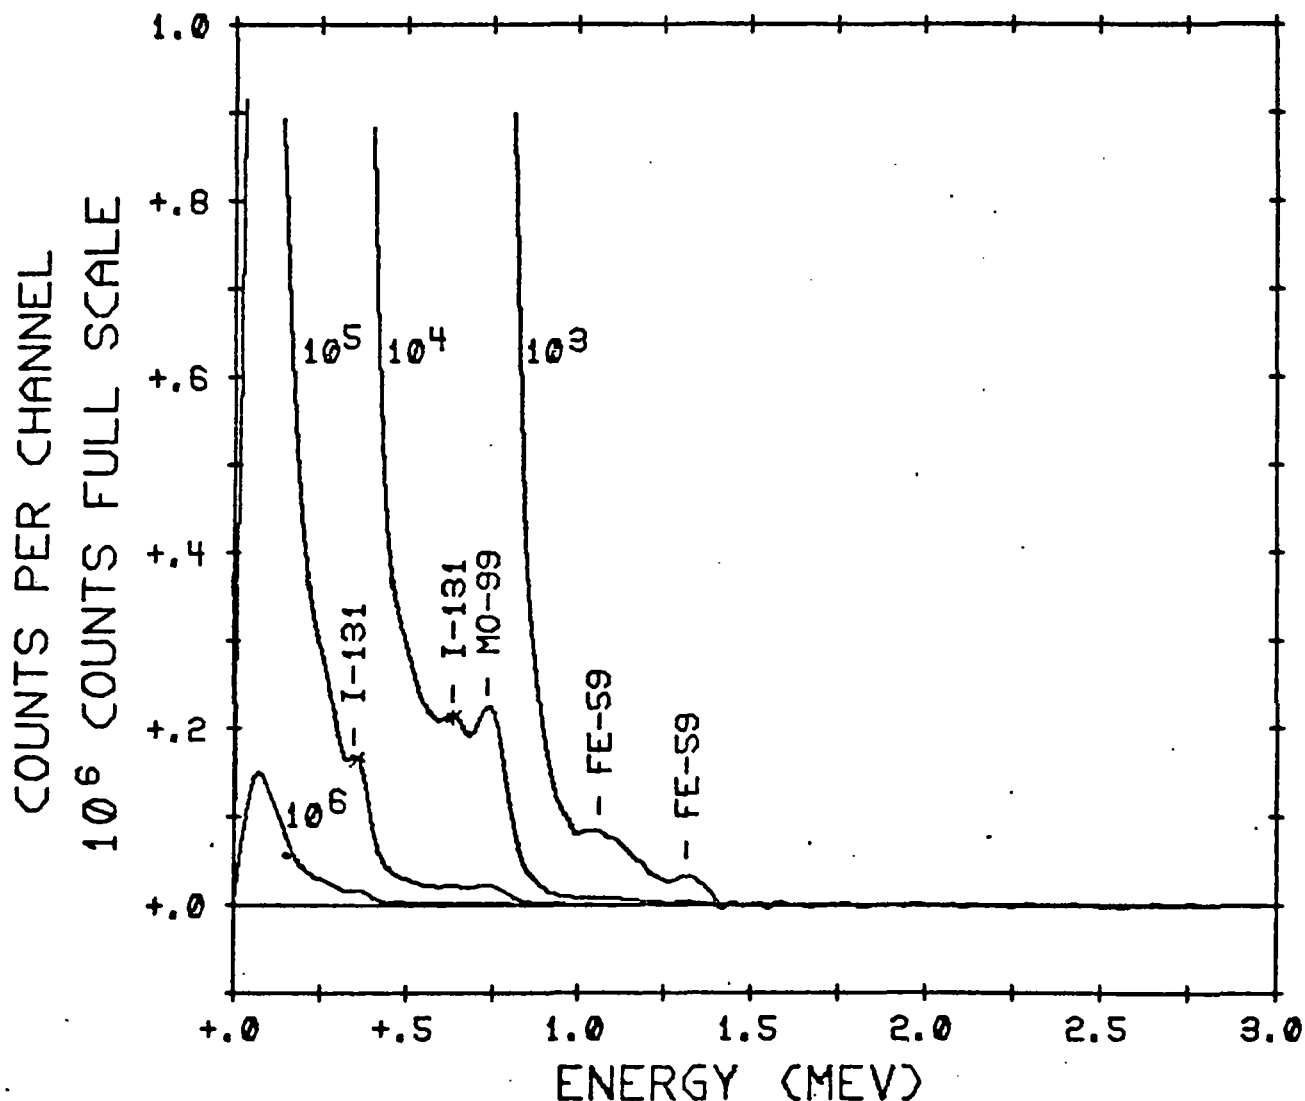
Figure 7. BACKGROUND-SUBTRACTED ENERGY SPECTRUM: MALLINCKRODT NUCLEAR SITE  
This spectrum characterizes the enhanced activity observed in Figure 6.

Figure 7 is a background-subtracted energy spectrum of the radiation from the area of increased activity. Photopeaks observed are 364 keV and 637 keV from  $^{131}\text{I}$ , 740 keV and 780 keV from  $^{99}\text{Mo}$ , and 1.095 MeV and 1.292 MeV from  $^{59}\text{Fe}$ . All three of these isotopes are received by the Facility for processing.

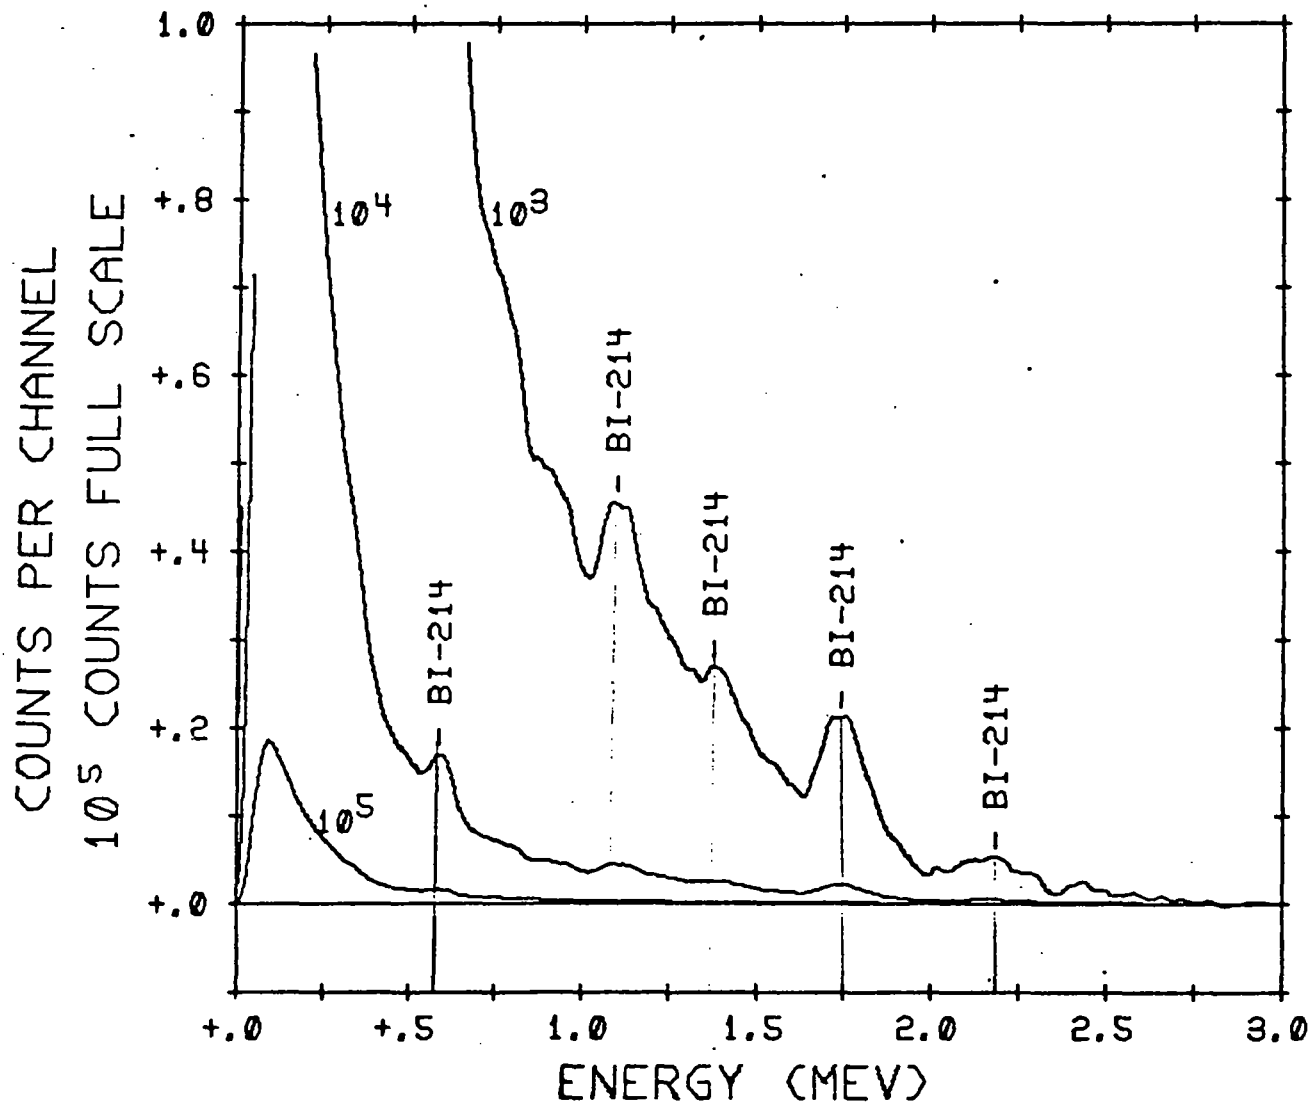
Figure 9. BACKGROUND-SUBTRACTED ENERGY SPECTRUM: LATTY AVENUE

This spectrum of gamma radiation was characteristic of the areas of increased activity at Latty Avenue and the airport as shown in Figure 8.

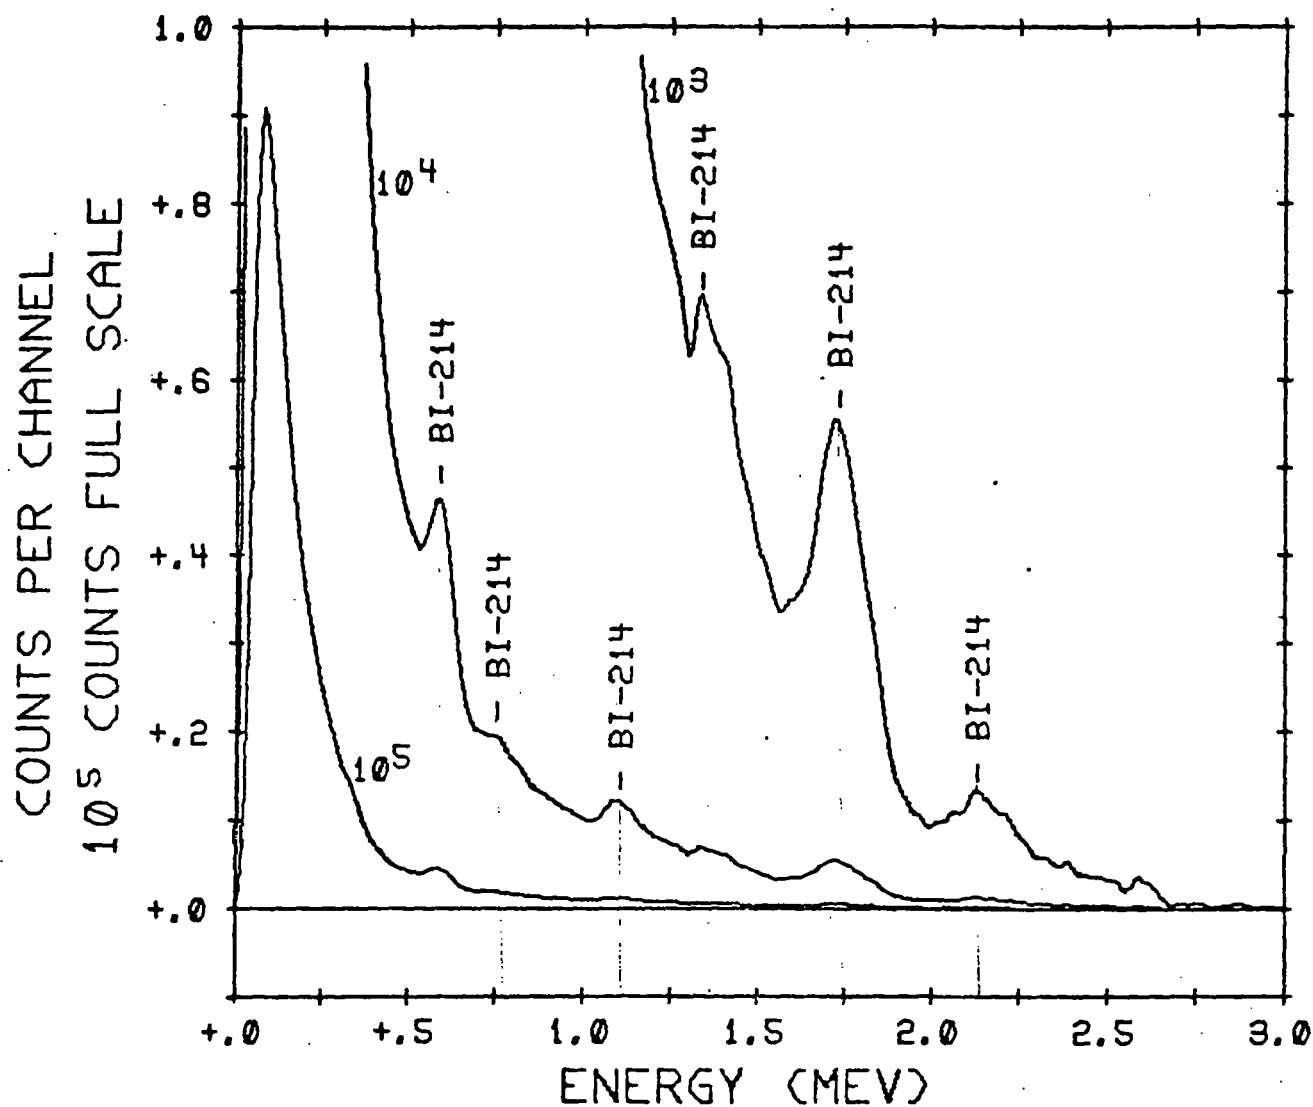
Figure 11. BACKGROUND-SUBTRACTED ENERGY SPECTRUM: WEST LAKE LANDFILL  
Photopeaks shown here characterize both areas of enhanced activity in Figure 10.

energy spectrum of the radiation characteristic of both areas of increased activity. Radiation from  $^{214}\text{Bi}$  accounts for all the major photopeak observed.

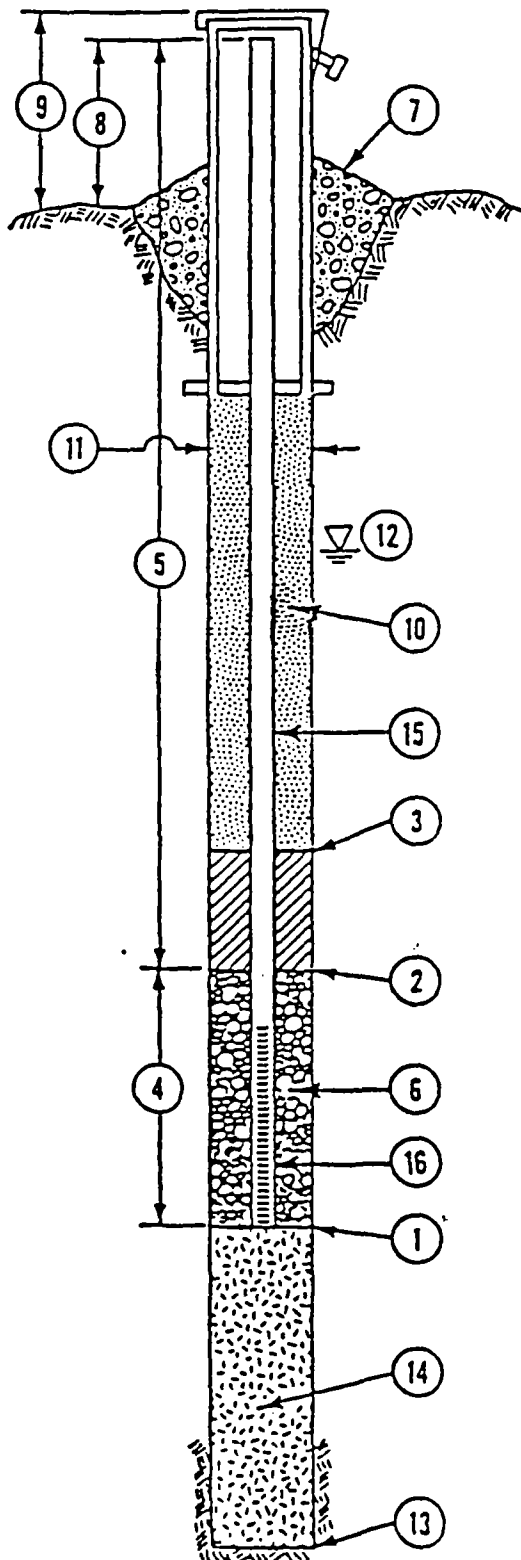
- ① DEPTH TO BOTTOM OF WELL POINT OR SLOTTED PIPE 15.7 FEET. \*
- ② DEPTH TO BOTTOM OF SEAL (IF INSTALLED) 4.5 FEET. \* *Bentonite Pellets*
- ③ DEPTH TO TOP OF SEAL (IF INSTALLED) 2.5 FEET. \*
- ④ LENGTH OF WELL SCREEN 10 FEET. SLOT SIZE 0.010.
- ⑤ TOTAL LENGTH OF PIPE 8.4 FEET AT 2 INCH DIAMETER.
- ⑥ TYPE OF PACK AROUND WELL POINT OR SLOTTED PIPE sand.
- ⑦ CONCRETE CAP. ☒ YES ☐ NO (CIRCLE ONE)
- ⑧ HEIGHT OF WELL CASING ABOVE GROUND 2.7 FEET.
- ⑨ PROTECTIVE CASING? ☒ YES ☐ NO (CIRCLE ONE)  
 HEIGHT ABOVE GROUND 2.8 FEET.  
 LOCKING CAP? ☒ YES ☐ NO (CIRCLE ONE)
- ⑩ TYPE OF UPPER BACKFILL cement slurry
- ⑪ BOREHOLE DIAMETER 8 INCHES.
- ⑫ DEPTH TO GROUND WATER 7 FEET. \*
- ⑬ TOTAL DEPTH OF BOREHOLE 18 FEET. \*
- ⑭ TYPE OF LOWER BACKFILL natural sand & silt
- ⑮ PIPE MATERIAL PVC.
- ⑯ SCREEN MATERIAL PVC.

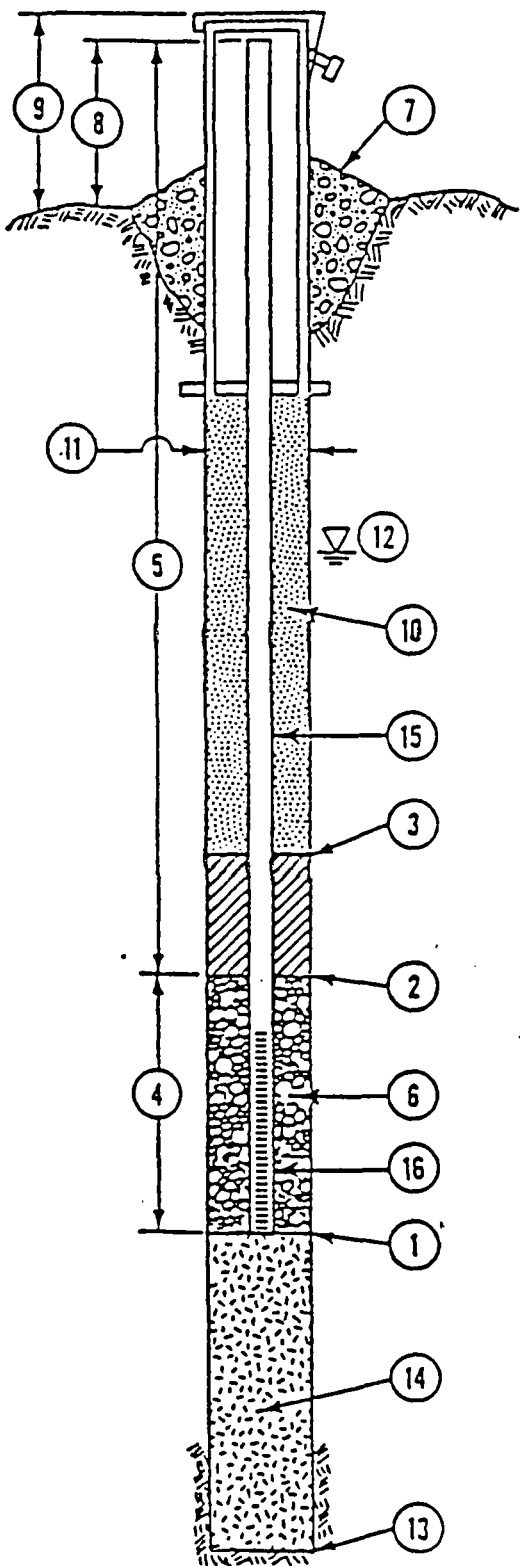
- 1 DEPTH TO BOTTOM OF WELL POINT OR SLOTTED PIPE 15 FEET. \*
- 2 DEPTH TO BOTTOM OF SEAL (IF INSTALLED) 3-5 FEET. \* Bentonite Pellets
- 3 DEPTH TO TOP OF SEAL (IF INSTALLED) 2 FEET. \*
- 4 LENGTH OF WELL SCREEN 10 FEET. SLOT SIZE 0.010.
- 5 TOTAL LENGTH OF PIPE \_\_\_\_\_ FEET AT 2 INCH DIAMETER.
- 6 TYPE OF PACK AROUND WELL POINT OR SLOTTED PIPE SAND.
- 7 CONCRETE CAP. (YES) NO (CIRCLE ONE)
- 8 HEIGHT OF WELL CASING ABOVE GROUND \_\_\_\_\_ FEET.
- 9 PROTECTIVE CASING? (YES) NO (CIRCLE ONE)  
HEIGHT ABOVE GROUND \_\_\_\_\_ FEET.  
LOCKING CAP? (YES) NO (CIRCLE ONE)
- 10 TYPE OF UPPER BACKFILL cement.
- 11 BOREHOLE DIAMETER 8 INCHES.
- 12 DEPTH TO GROUND WATER 9 FEET. \*
- 13 TOTAL DEPTH OF BOREHOLE 15 FEET. \*
- 14 TYPE OF LOWER BACKFILL N/A.
- 15 PIPE MATERIAL PVC.
- 16 SCREEN MATERIAL PVC.
